Fall 2025

Dear No-Rosion Customer,

In this newsletter, we'll share details of three recent examples of gasoline corrosivity. The third one may actually surprise you, because it involves gasoline containing 0.0% ethanol!

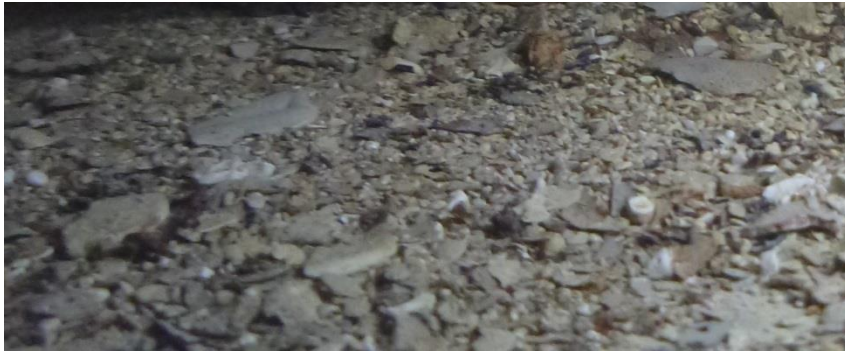
*Please see the attached photo of the debris. Do you have any idea what it could be? The color ranges from yellowish/orange, to brown. The tank has no bladder. It is aluminum tank, holds 26.4 gallons, so it is not rust as there is no iron. Some of the pieces are larger, looking like flakes of something. They too turn to a fine dust when touched.*

He did send us a sample, and we analyzed it in the lab. We found it to consist of a combination of aluminum oxide salts, and degraded epoxy liner. The aluminum oxide results from corrosion of the aluminum tank. Normally it is white to off-white in color. However, in this instance, it had been stained to orange/brown from the decomposition materials associated with the epoxy liner. Specifically, before the development of today's more advanced solvent-free epoxy coatings, solvent-based polyamide epoxies were the standard when this 1995 Lamborghini was manufactured. As evidenced by this problem, these more primitive solvent-based linings often proved inadequate for long-term corrosion protection resulting from ethanol and/or the heavy, corrosive water layer that sinks to the bottom of the tank when phase separation occurs in aged fuel.

Moving forward, the customer will replace the tank with a new one with modern epoxy that is more resilient against ethanol. And as an added layer of protection, he'll use **No-Rosion Fuel System Combustion Optimizer**, as it's formula includes a corrosion inhibitor to protect metals, a dispersant to prevent water absorption by ethanol that can result in phase-separated gasoline, and stabilizer to prevent oxidative breakdown of gasoline.

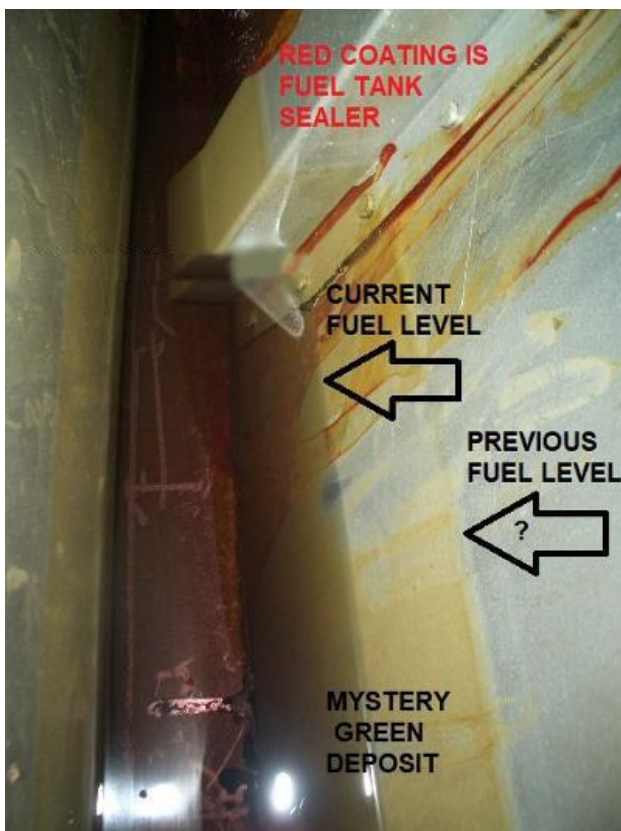
\* Photo courtesy of Mr. Dyke Ridgley

*Please see the photo included with this email. It is from the inside of the aluminum fuel tank of our 1957 Ferrari 250 Testa Rossa.*

*When we acquired the car about 10 years ago, the tank was leaking and also had the old "white" sealer coming loose. We removed the old sealer and applied new "red" sealer to only one lower corner. That is the "red" lines you see in the photo. For the last few years, we have only used leaded racing gas in the car. However, we continue to find "residue" in the carburetors and now it is obvious it is in the tank itself.*

Assuming this fuel does contain 25% toluene, it's corrosive degradation byproducts are corroding the aluminum tank. They also attacked the vintage white tank sealer, which is not an impermeable solvent-free epoxy coating.

We also obtained a fuel sample from the customer, to confirm the composition of the white contaminant. Lab analysis identified it as remnants of the old tank coating, as well as aluminum oxide salts. We then obtained the SDS for the KBS Gold Standard Tank Sealer, and confirmed it is indeed an advanced solvent-free epoxy coating that is capable of remaining chemically impervious to the high concentration of toluene in the race fuel they plan to continue using. And the mystery green deposit was copper corrosion residue from the bronze pickup tube.

There remains the issue of the corrosive 25% toluene fuel. For this reason, the customer will be adding and maintaining at all times the proper dose of **No-Rosion Fuel System Combustion Optimizer**. The corrosion inhibitor in **No-Rosion** will protect the various metals in the tank, engine, and entirety of the fuel system.
